ANGELICA DAM

NDI - PA 00705

PHASE I INSPECTION REPORT NATIONAL DAM INSPECTION PROGRAM

Name of Dam: Angelica Lake Dam ID #PA00705
State Located: Pennsylvania
County Located: Berks County
Stream: Angelica Creek
Coordinates: Latitude 40° 18.7', Longitude 72° 55.4'
Date of Inspection: April 3, 1979

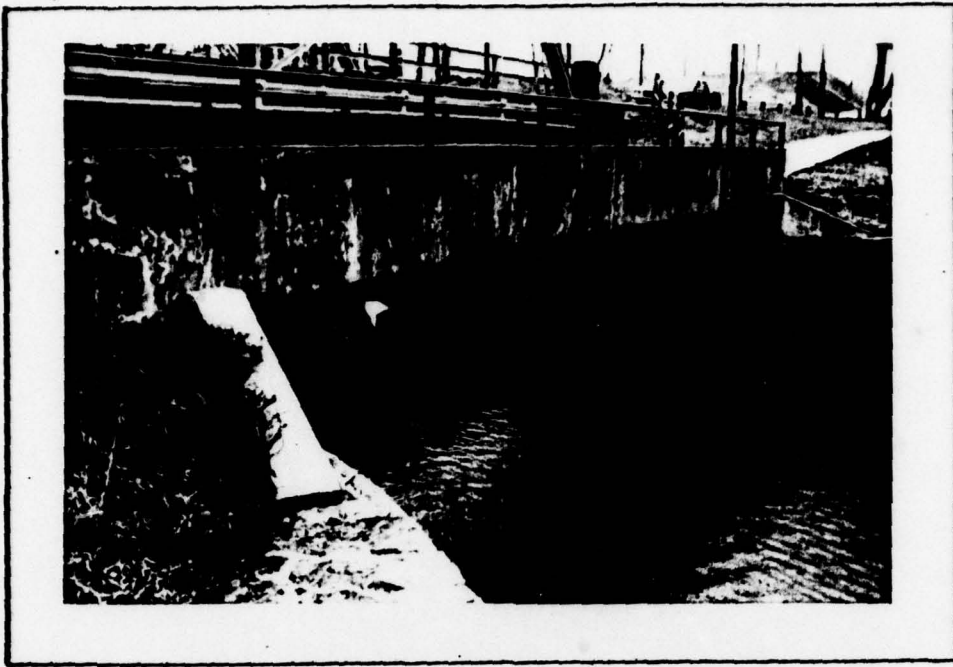
b. Dam. The embankment and masonry wall appear to be in fair condition. The crest of the dam is slightly eroded and undermined where the concrete foot bridge over the spillway ties into the embankment. Significant erosion has taken place around an 18-inch diameter pipe which extends from the right abutment downstream of the spillway near the bridge abutment. This pipe apparently provides road drainage and the pipe outlet is located about 9 feet above the downstream spillway apron. The masonry wall is overgrown with vegetation and brush which could conceal any seepage through the wall.

*VIEW OF THE FOOT BRIDGE OVER THE SPILLWAY
WITH THE ROAD BRIDGE IN THE BACKGROUND*

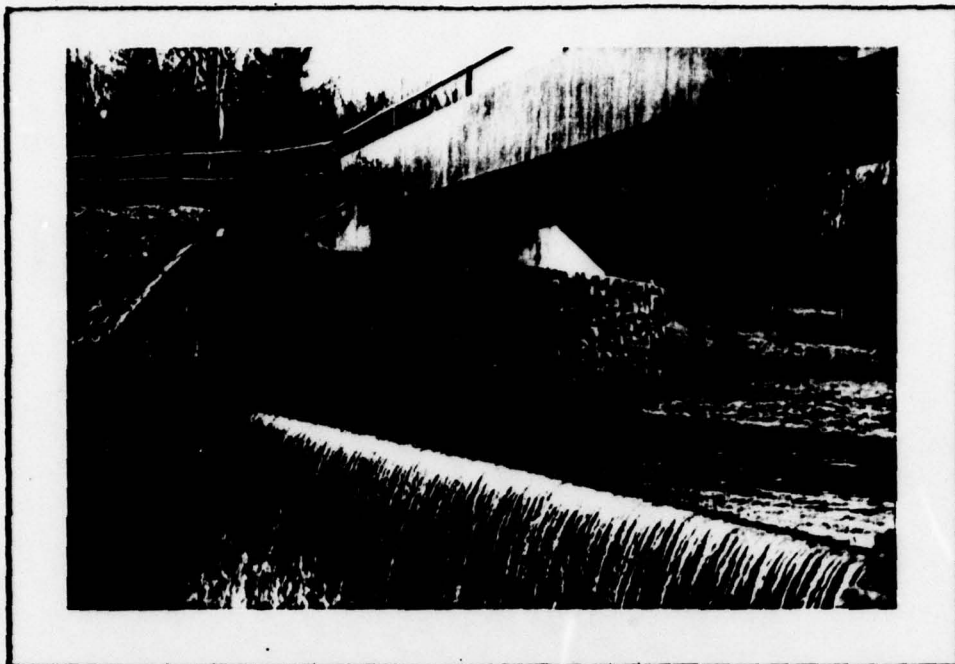
The spillway and training walls appear to be in good condition. Minor surface cracking is evident in the upstream training walls, but these cracks do not affect the integrity of the structure in any manner.

***SPILLWAY CREST, RIGHT SIDEWALL, AND FOOT BRIDGE
AS VIEWED FROM THE LEFT SIDEWALL***

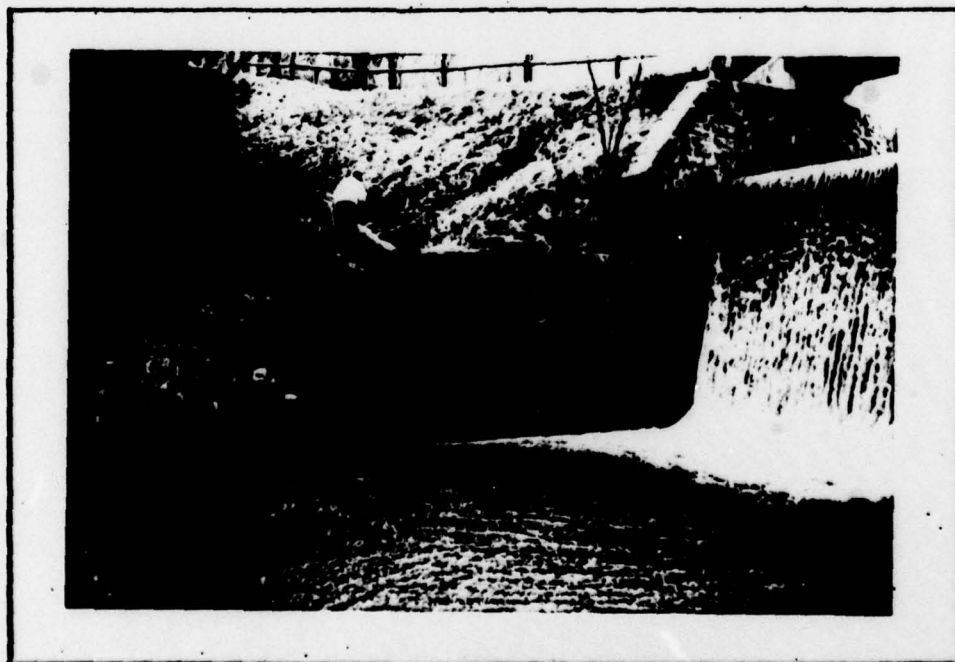
***VIEW OF THE RIGHT SIDEWALL OF THE SPILLWAY SHOW-
ING THE ROAD DRAIN PIPE AND THE BRIDGE ABUTMENT***
